Food Distributor has a 400,000+ SF Facility that Needs a Wireless Upgrade, but the Cold Storage Rooms Have Temperatures Reaching -10F.

## Client

Performance Food Group is a large food distribution and supply chain that is nationally recognized through 85,000 customer locations and 36 broadline locations. They engaged ASD<sup>®</sup> to replace their wireless infrastructure throughout their storage facility in Hickory, North Carolina.

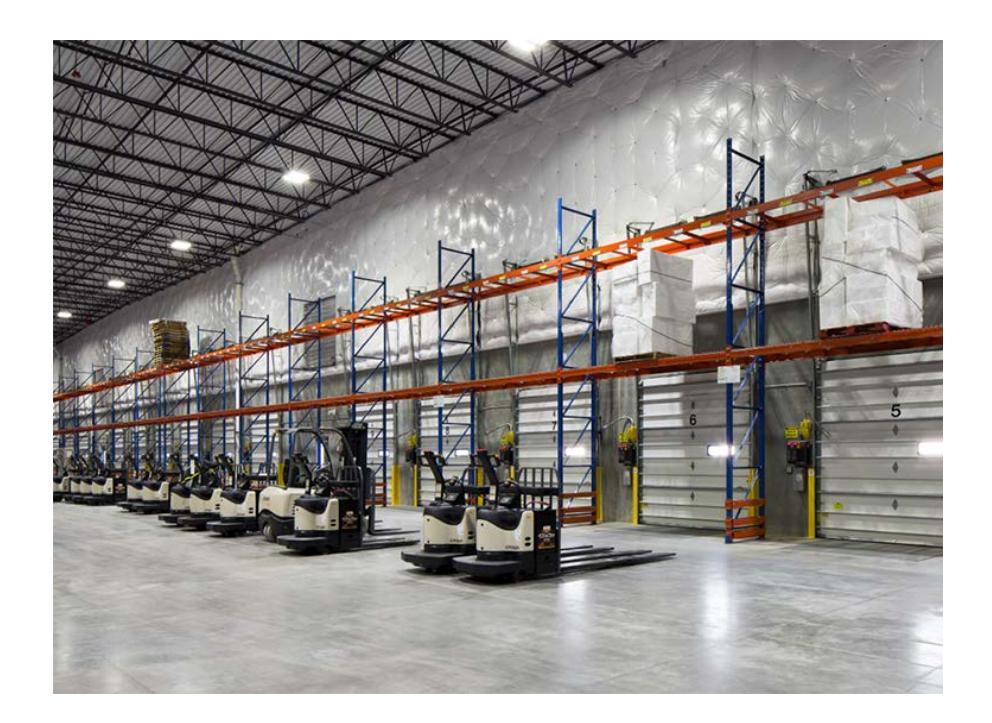
The facility had high ceilings with steel beams, this posed a challenge because when the external antennas are too close to steel it can absorb and hinder the wireless signals. Our engineers decided to mount the antennas below the steel rafters and keep the access point above the rafters. This allowed the signal to propagate properly and minimized the amount of space they occupied.

The cold storage areas, which totaled more than 280,000 sq. ft., were both kept at temperatures well below those recommended by manufacturers for the wireless access equipment. To combat this, special enclosures that were heated with POE were installed to house the equipment.
